Manhole Inspection Summary

Manhole # S250__009MH

Insp Date: **4/4/08 11:47 AM**

Location Address: **1207 WARD ST.**

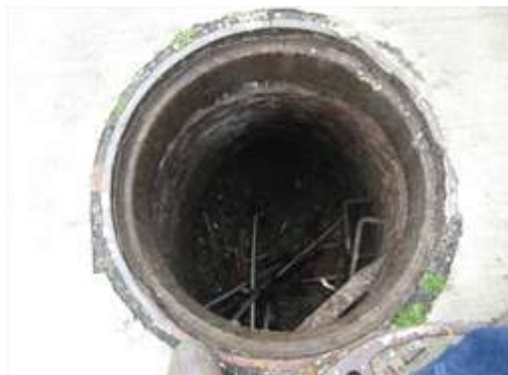
Defect 3

Frame Offset: **0** (in.) Condition: ☐ Sound ☒ **Cracked** ☐ Leaks

Condition: ☐ Sound ☐ Cracked ☐ Root Intrusion ☐ Deteriorated ☐ Leaks ☒ **Debris**

Channel Debris, Crack in Frame @ 12 O'clock

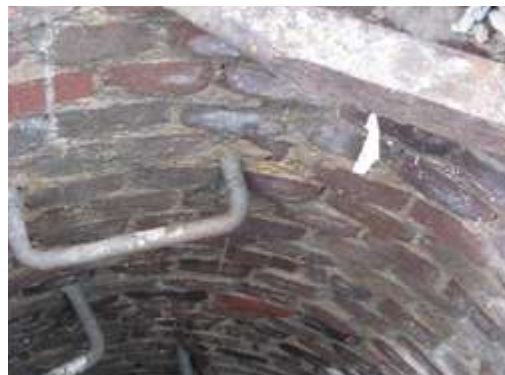
Defect 2

Infiltration: ☐ None ☐ Joint ☐ Cracks ☐ Mortar ☐ Roots ☒ **Wall**

EVIDENCE OF CORBEL INFILTRATION

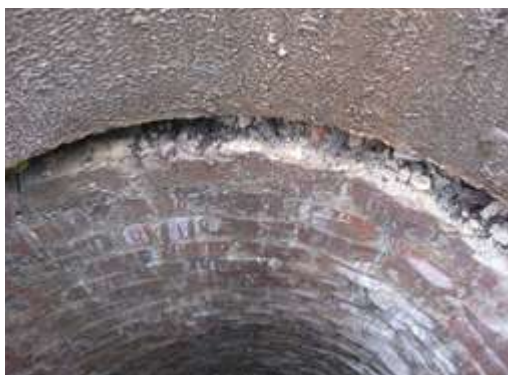
Defect 1

Condition: ☐ Sound ☐ Cracked ☐ Root Intrusion ☒ **Loose Brick** ☒ **Deteriorated**

Infiltration: ☐ None ☒ **Joint** ☐ Cracks ☒ **Mortar** ☐ Roots ☐ Wall

chimney is deteriorated and has loose/missing bricks with signs of flow at joint & mortar
